# CASE STUDY

## Bearing Isolator | Gearbox

### CUSTOM ENGINEERING AND COMMITMENT TO CUSTOMER SEAL THE DEAL AT ARIZONA COPPER MILL

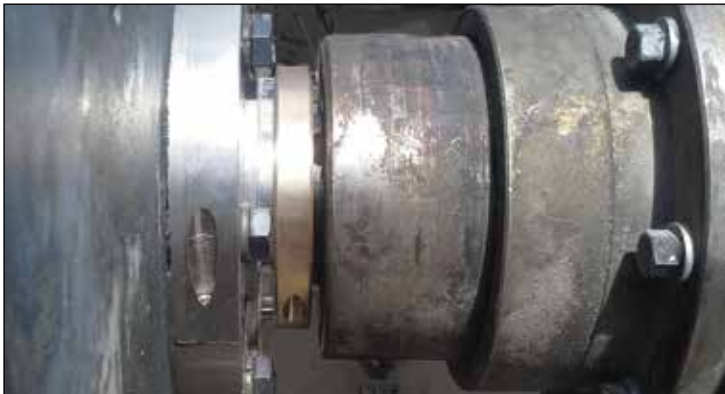
*A split custom engineered Inpro/Seal Bearing Isolator provides permanent bearing protection on a Sag Mill Gearbox at a copper mine in the Southwest United States.*

Gillespie explained that high oil levels and oil splash make gearboxes notoriously difficult to seal, especially in industrial rotating applications. Inpro/Seal's sealing solution for the gearbox is based on the patented VBXX-D Bearing Isolator. This is a non-contacting, compound labyrinth seal that consists of a stator and a rotor. The stator has a large D Groove that captures oil attempting to flow down the shaft out of the housing. Through a drain port, the captured oil is channeled back to the gearbox oil sump. The rotor prevents outside contaminants from entering the gearbox by collecting them in the labyrinth design. Centrifugal force then expels the captured contaminants to the outside environment. The result is a permanent, non-contacting seal that efficiently keeps the lubricant in the gearbox. It also prevents outside contaminants, such as water and dirt, out of the gearbox bearing housing.

Inpro/Seal modified a standard VBXX-D Bearing Isolator to fit the gearboxes unique challenges. This custom engineered design included:

- Being split to allow seal installation without decoupling equipment
- A larger D Groove to capture the volume of oil flowing through the system
- An external drain and revamped system to return oil to the sump

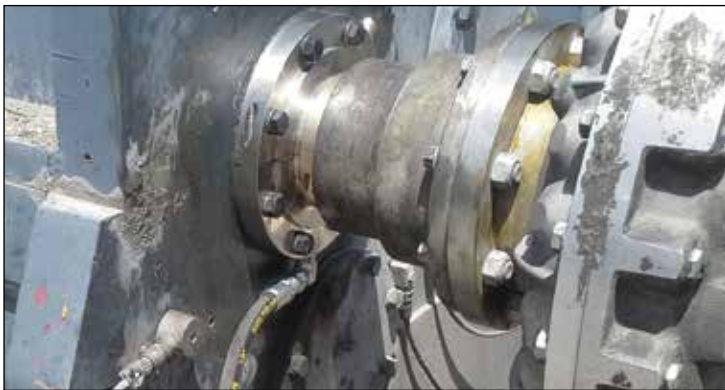
*An external drain was designed to accommodate the operational flood in the Sag Mill Gearbox bearing housing.*

An operational flood in the bearing housing compounded the sealing challenge for the SAG mill gearbox. Unlike most gearboxes that splash oil into the bearings, the gearbox on the SAG mill pumped oil into the center of the double row spherical roller bearings. This ensured continuous lubrication to the bearings, but also tended to throw the oil toward the lip seal. Oil that was attempting to flow back through the bearings to return to the sump was impeded, creating an operational flood. This placed additional pressure on the lip seal and increased their failure rate. A permanent solution needed to be able to perform in an operational flood and be installed on-site without decoupling equipment.
